ANALYSIS OF BROWNFIELD CLEANUP ALTERNATIVES

**CITY OF MONROE
OUACHITA CANDY COMPANY
211-305 WALNUT STREET AND
RIGHT-OF-WAY ACCESS
MONROE, LOUISIANA**

**EPA BROWNFIELDS COOPERATIVE
AGREEMENT BF-01F65201-0**

PPM PROJECT NO. 11472001/04-CP/01ABCA

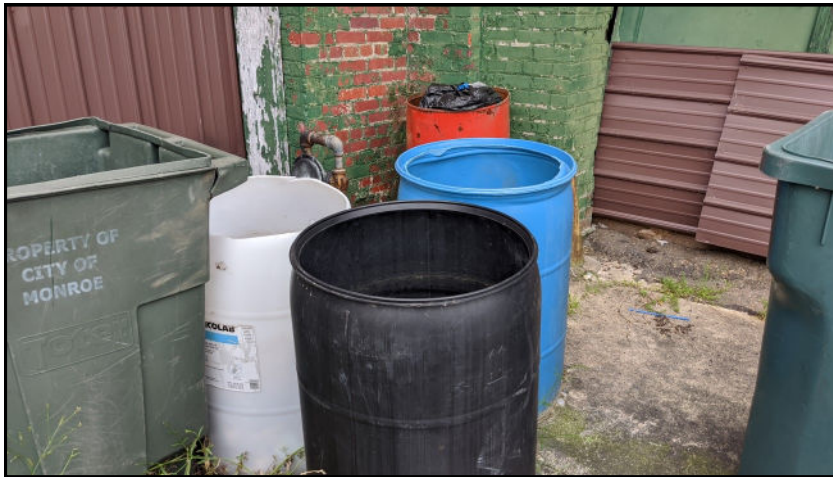
PHOTO 13
Solid waste drums on the west side of the subject property.

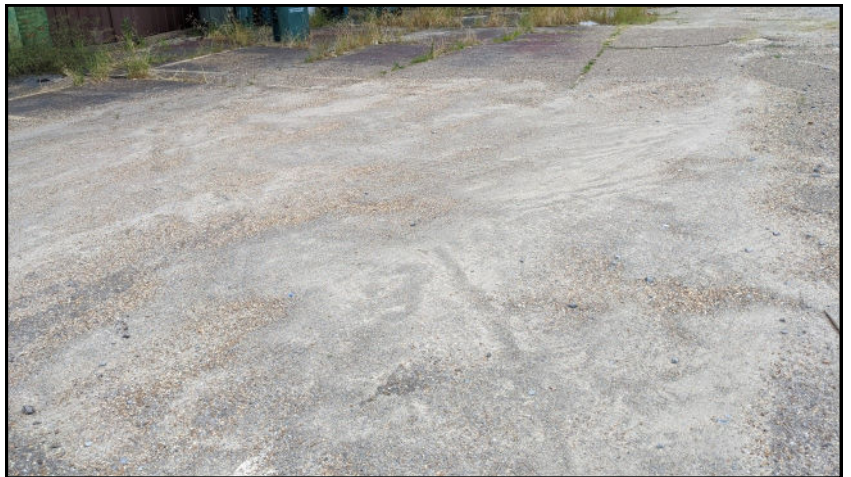
PHOTO 14
Approximately location of former used oil UST pit.

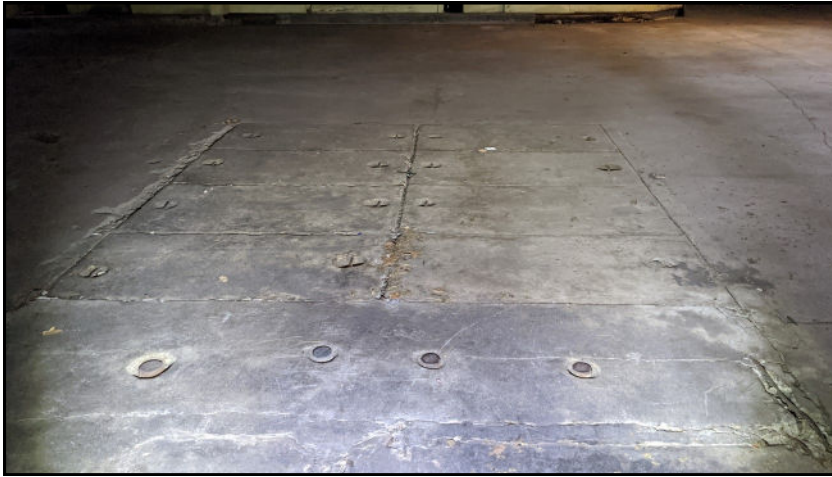
PHOTO 22
Scarring in concrete of stor-
age area.

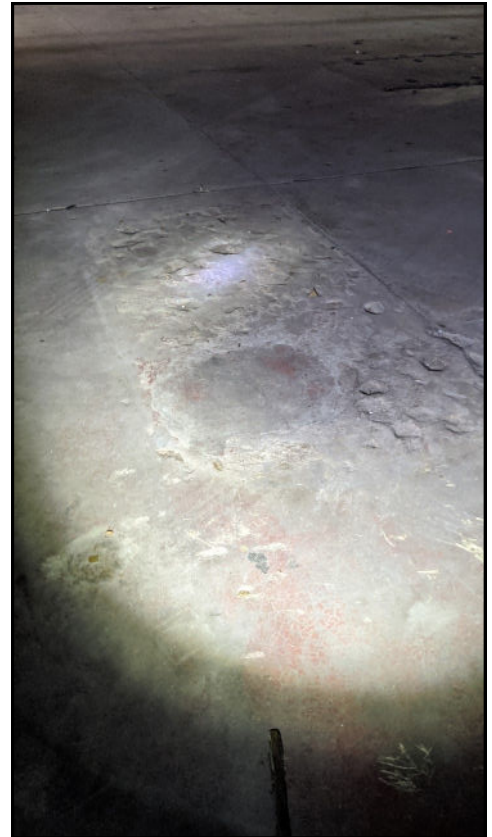
PHOTO 23
Pitting in concrete in the stor-
age area.

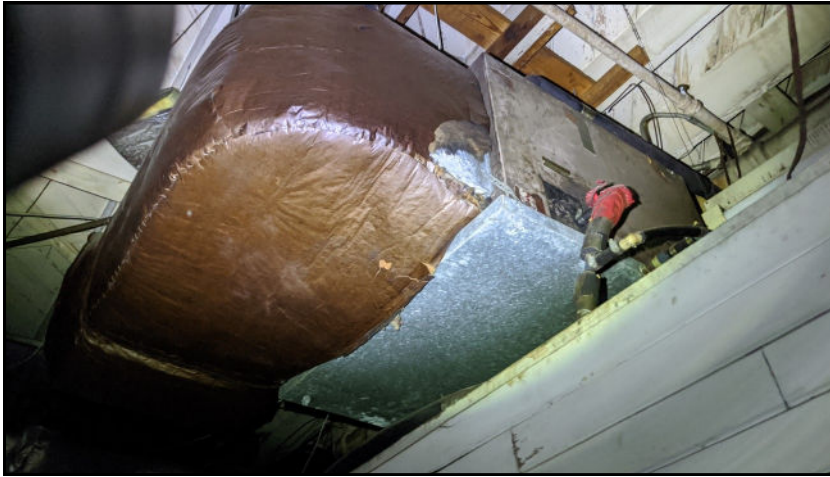
PHOTO 31
Duct insulation in former
bottling plant.

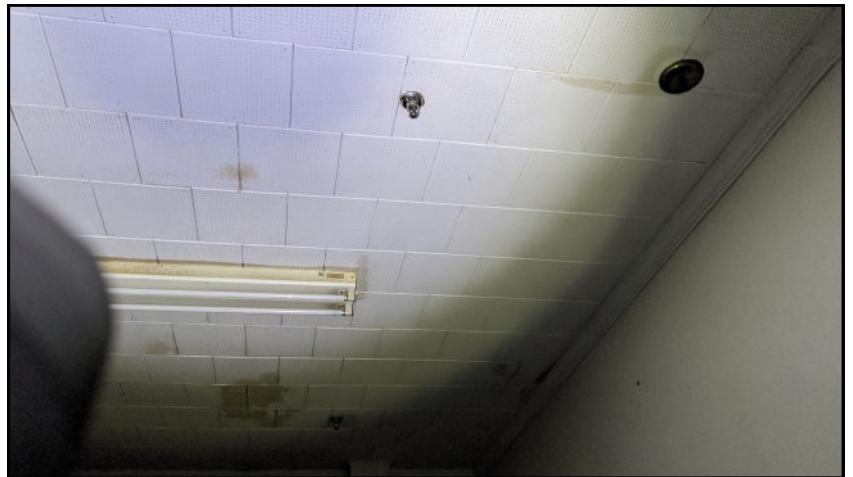
PHOTO 32
Ceiling tile sample.

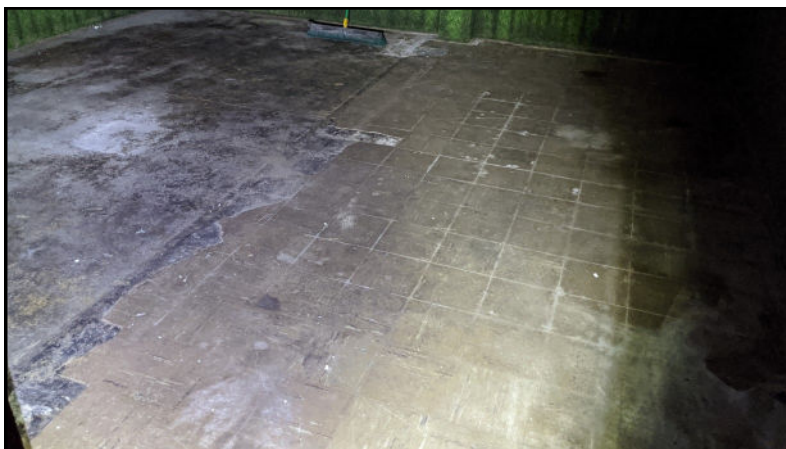
PHOTO 33
Floor tile sample.

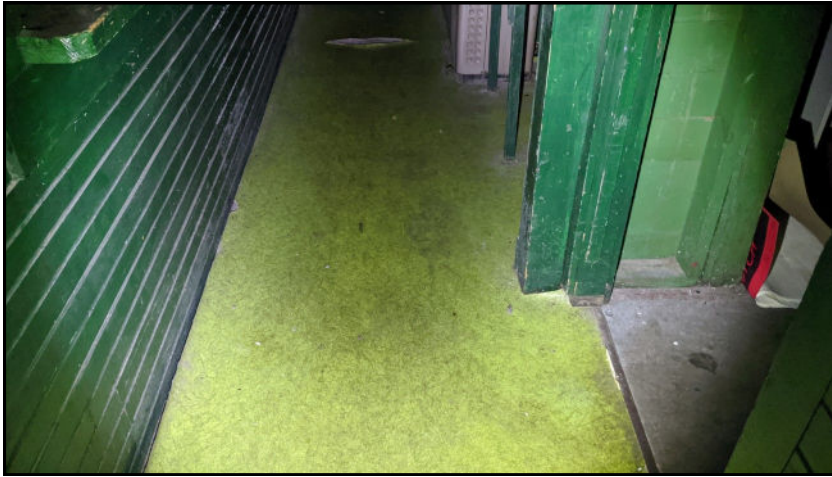
PHOTO 34
Floor linoleum flooring and
paint in common area.

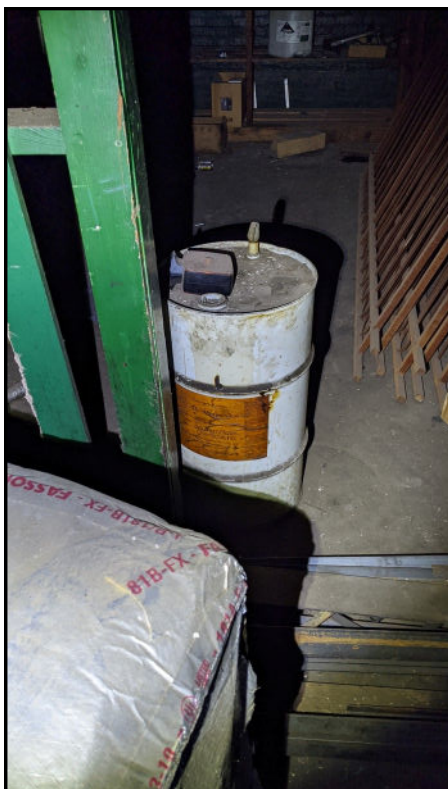
PHOTO 39
Chemical containers in storage.

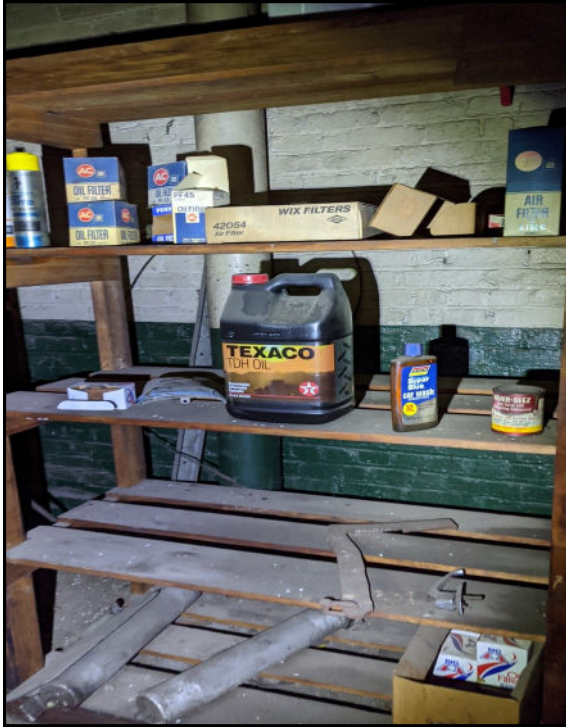
PHOTO 40
Chemical containers in storage.

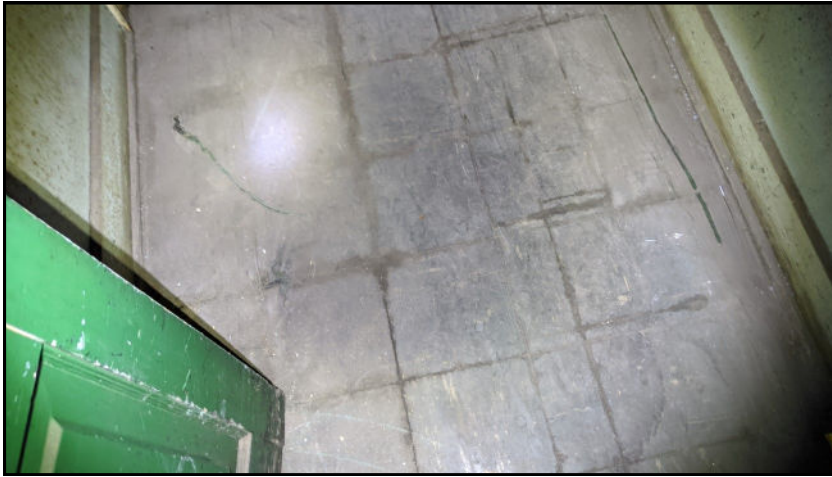
PHOTO 46
Flooring sample in hall.
