# **BROWNFIELD CLEANUP PLAN**

# CITY OF MONROE OUACHITA CANDY COMPANY 211-305 WALNUT STREET MONROE, LOUISIANA

**ACRES NO. 243049**

**SEPTEMBER 30, 2022**

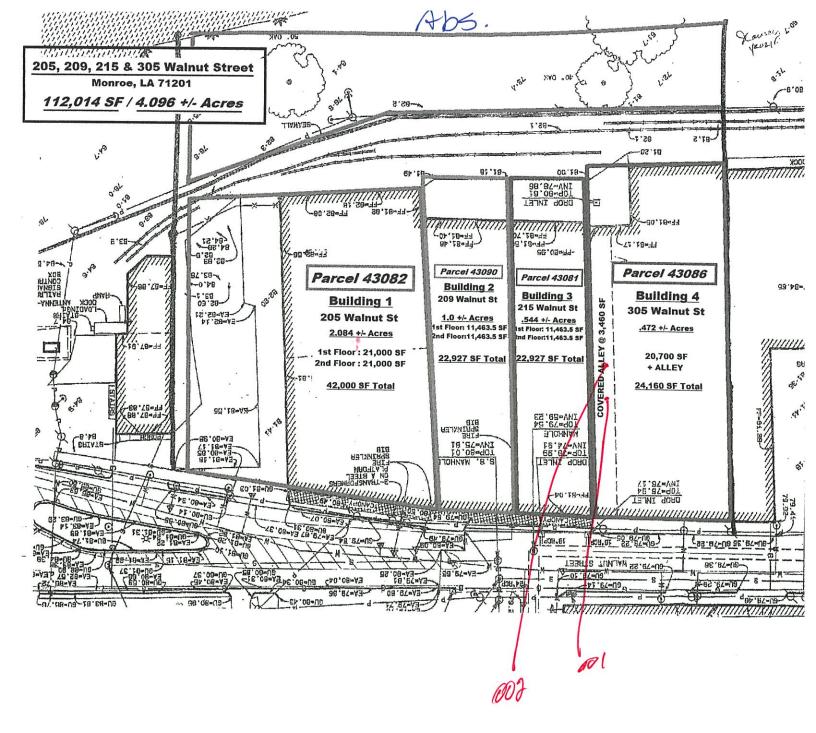
SAMPLE LOCATION DRAWING(S)

No suspect material in building 2 For espected. 2nd Floor not inspected - dearned unsafe. LABORATORY ANALYSIS REPORT

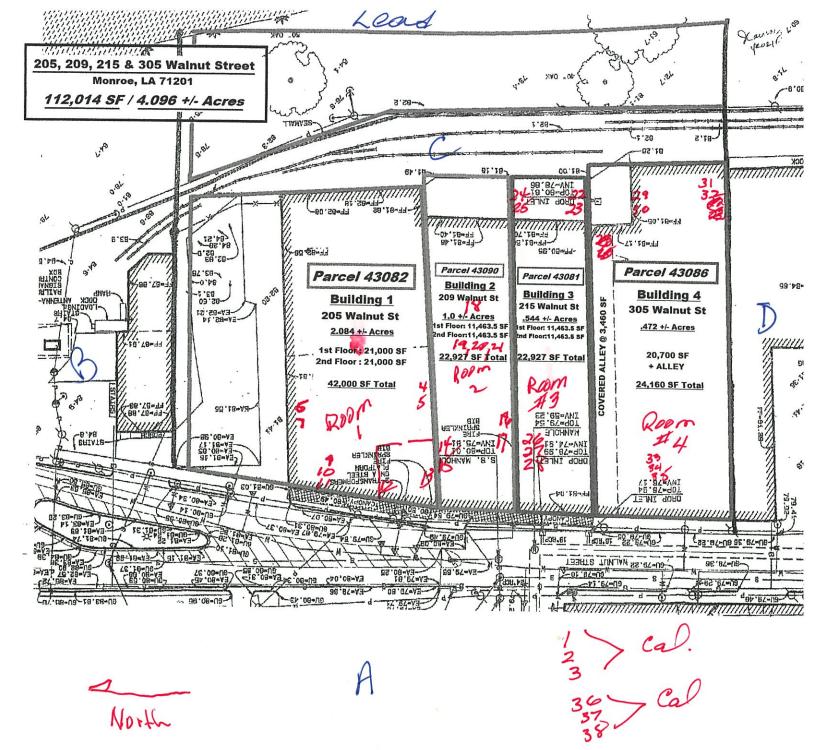
LEAD LOCATION DRAWING(S)

East and ut building I has 9x9 ET + black mastic 2nd Floor is unstable and unsafe, Not surveyed as for Client. Cailing not fainded in in room # 3+ # 4
