# **BROWNFIELD CLEANUP PLAN**

# CITY OF MONROE OUACHITA CANDY COMPANY 211-305 WALNUT STREET MONROE, LOUISIANA

**ACRES NO. 243049**

**SEPTEMBER 30, 2022**

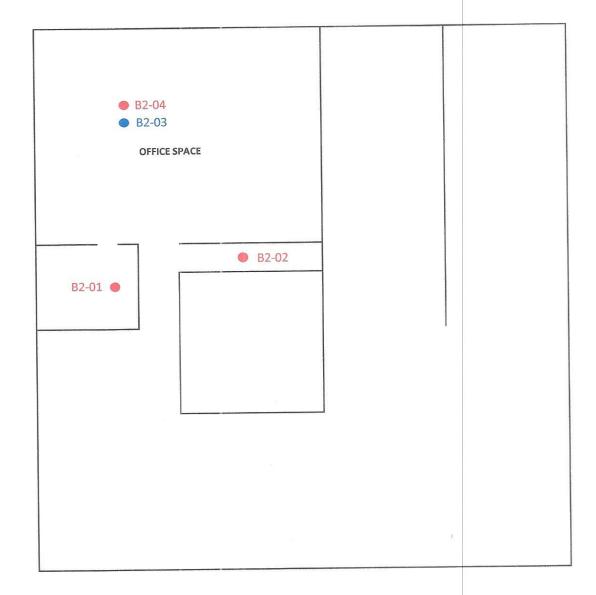
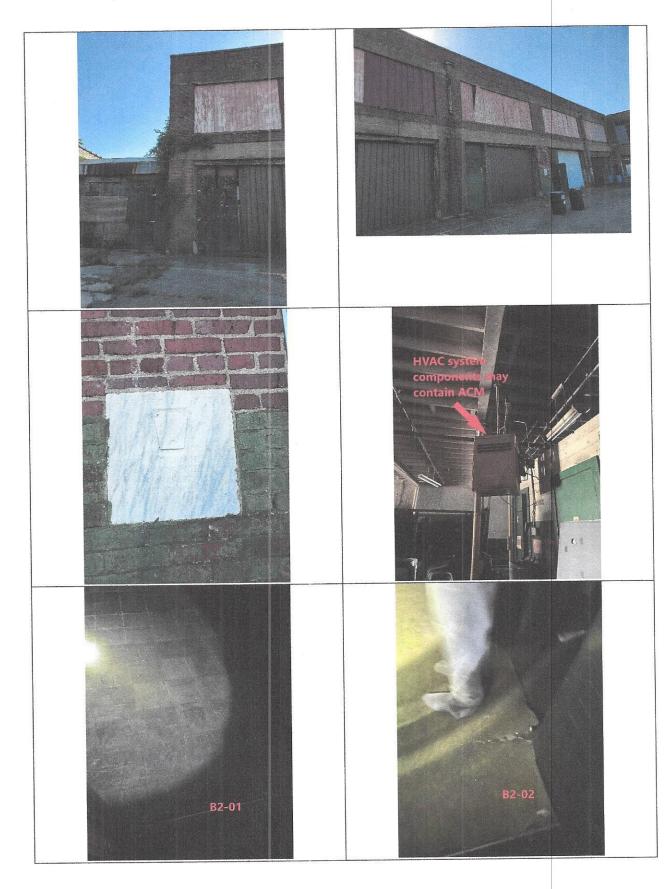
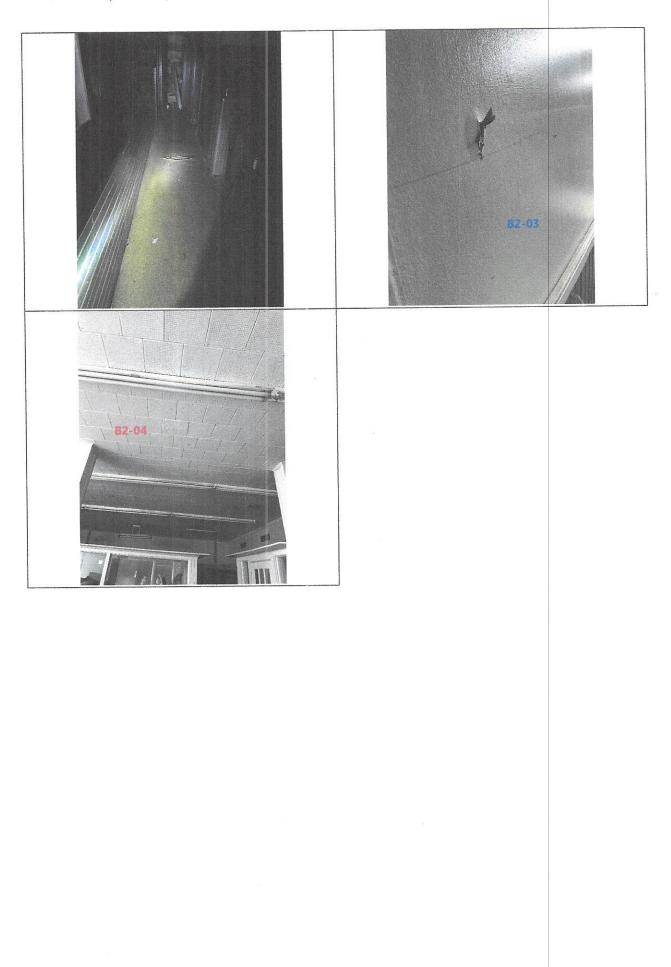
PAC Environmental Specialists, LLC Commercial Building 211-305 Walnut St. Inspection Date: 06/29/2021 Asbestos Inspection Kadie Romano Wheat LDEQ Cert # MI192255 Building 2

Red Font= Asbestos-Containing Material (ACM)

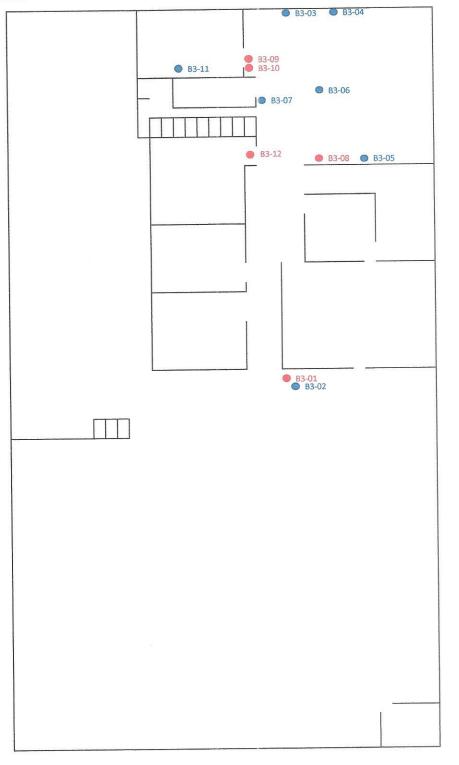
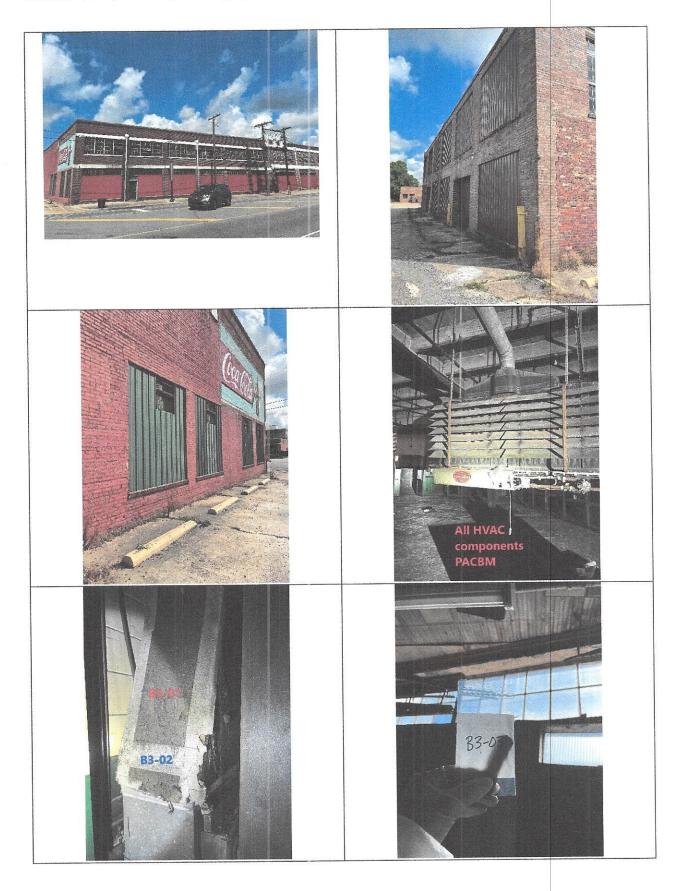
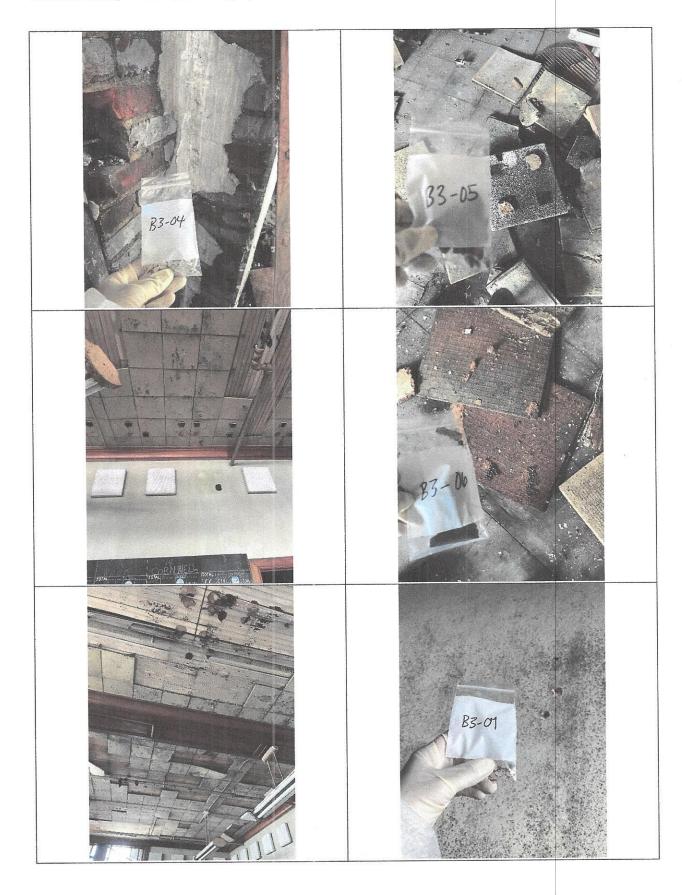
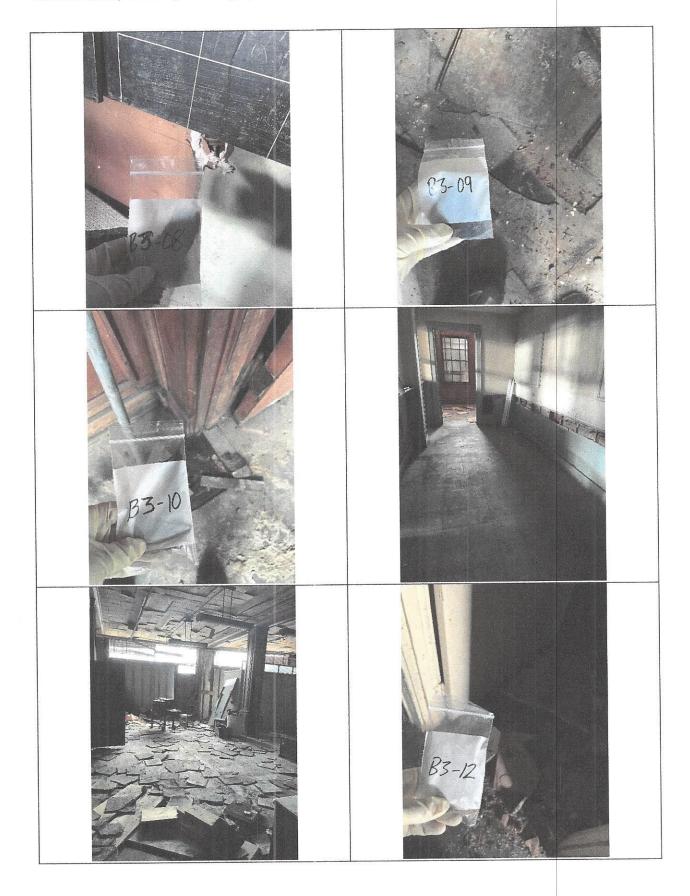
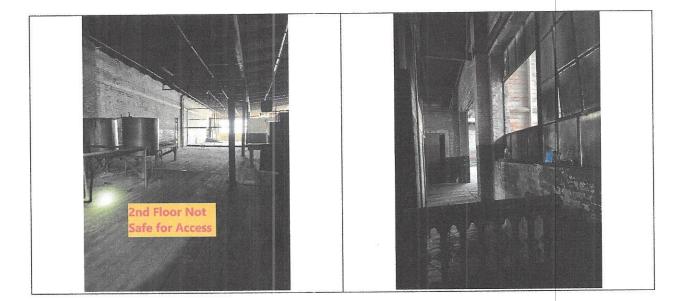
shutt Asbestos Inspection Kadie Romano Wheat LDEQ Cert # MI192255 **Building 3 First Floor**

#### Red Font= Asbestos-Containing Material (ACM)
